Study Report on 552A-101 Alignment and Rework 12/3/69

SPECIAL STUDY REPORT COVERING

INSPECTION OF 552A-101

To determine existing alignment condition and feasibility of increasing system's measuring accuracies.

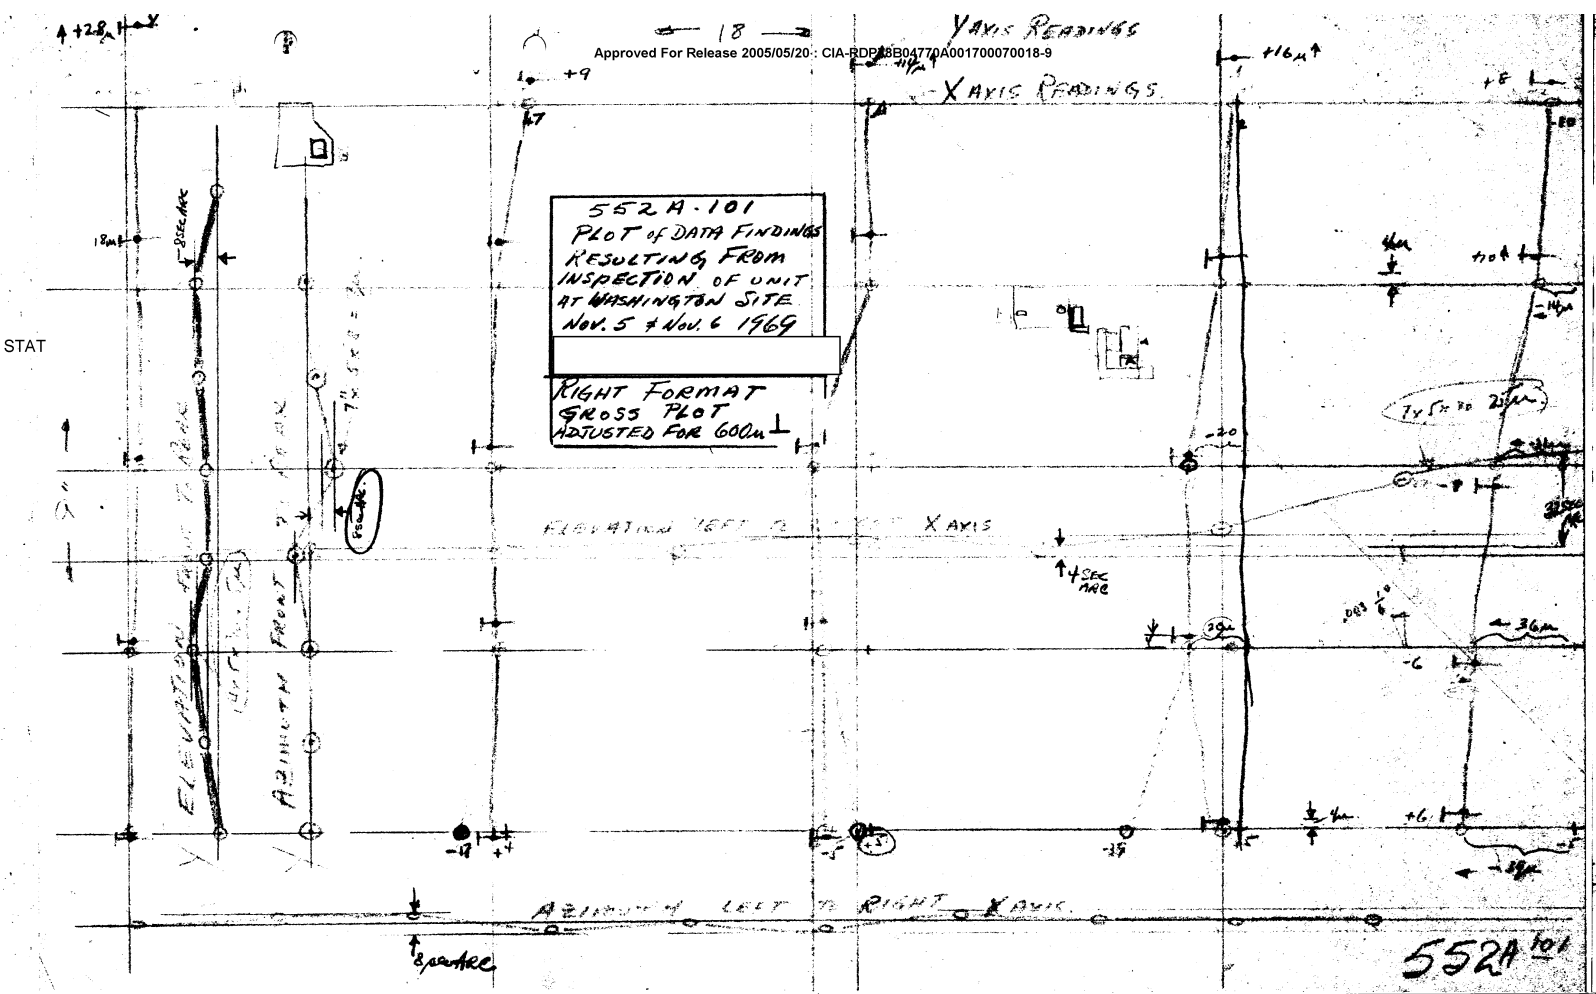
552A-101 GROSS PLOT (RIGHT FORWART)
INSPECTION FINDINGS NOV. 5-6, 1965 by MHC & M.D.
GROSS ADJUSTMENT FOR 600 MICRON PERPENDICULARITY

X-Y objective motions were collimated both for azimuth and elevation. Measurements were also made using 9 X 18 inch calibrated grid. Right format shows the following gross readings and observations:

Perpendicularity 600 micron shift was recorded; this was lowered to about 160 microns during inspection, but will require further alignment and work to meet the design goal accuracies.
